FOREST EVALUATION AND  
STRATEGIC MANAGEMENT PLAN  
FOR FIRST PRIORITY AREAS  
LOWER GWYNEDD TOWNSHIP  
AUGUST 26, 2025

Prepared for:  
Lower Gwynedd Township  
1130 N. Bethlehem Pike  
Spring House, PA 19477

Prepared By:  
Valerie Liggett, ASLA, R.L.A.  
ISA Certified Arborist #PD-2334A  
ISA Tree Risk Assessment Qualified

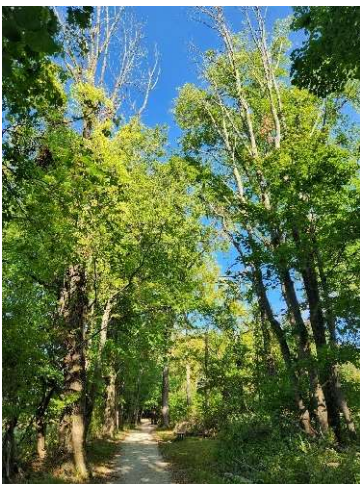
Dead Ash Trees

- Recommendations:
  - An estimated 60-70 hazardous trees have been removed from along the trail. An annual evaluation should be conducted thereafter to determine if additional removals or other tree work would be advisable for this trail segment. Regarding any additional tree removal, where tree parts are small enough to chip, chips should be spread within the surrounding wooded areas. Stumps should be left in place to decompose. Some larger tree parts should be left in place to decompose, so long as large piles of logs are not created.

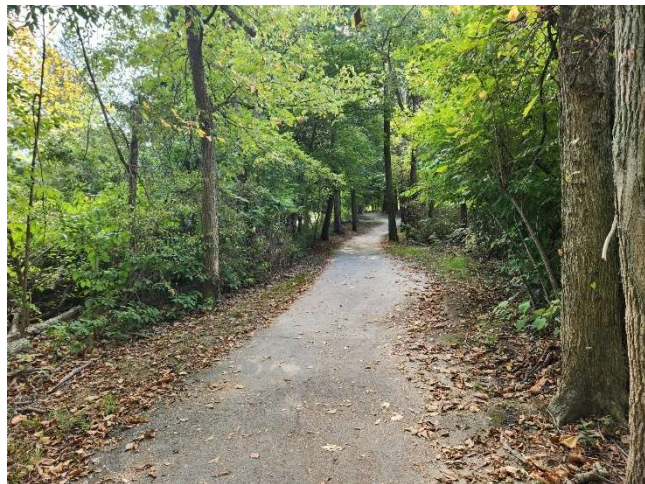
Invasive understory growth along trail near trailhead

- Due to the confined nature of the woodlands corridor along this trail segment, and the relatively confined location of dense stands of invasive understory species, this may be a good location for selective invasives removal and supplementary shrub and tree understory planting within more shaded areas which currently lack understory growth. Planting of shade-tolerant native species within more open, shaded understory areas would require relatively little removal of invasives.

- Some understory clearing at the trailhead across from Bethlehem Baptist Church may be advisable for the purposes of improving sight lines at this access point.

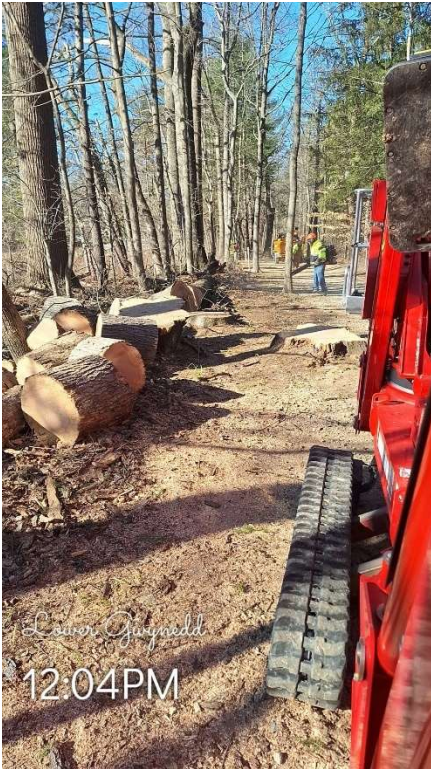
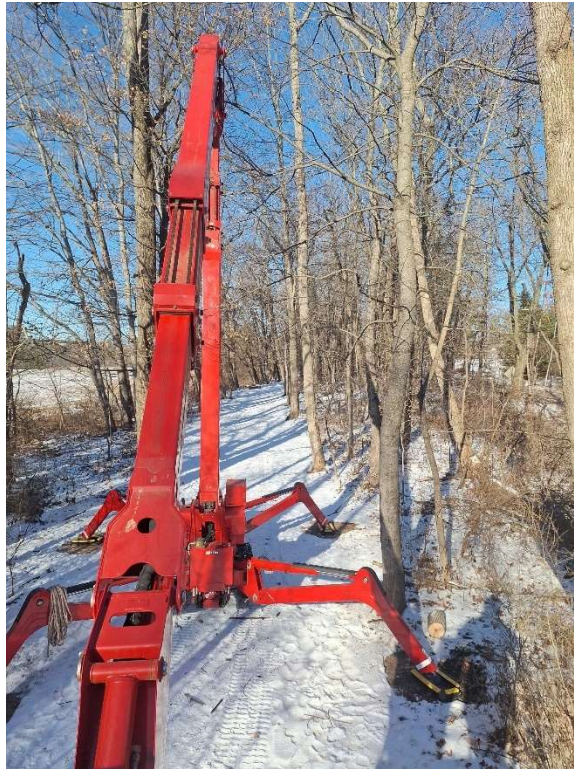
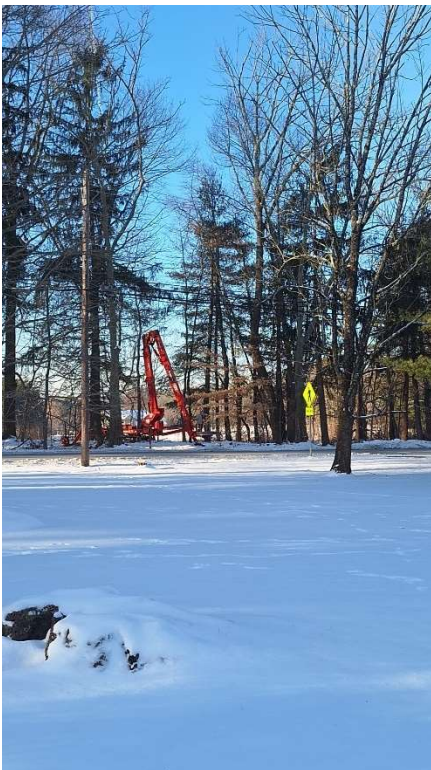
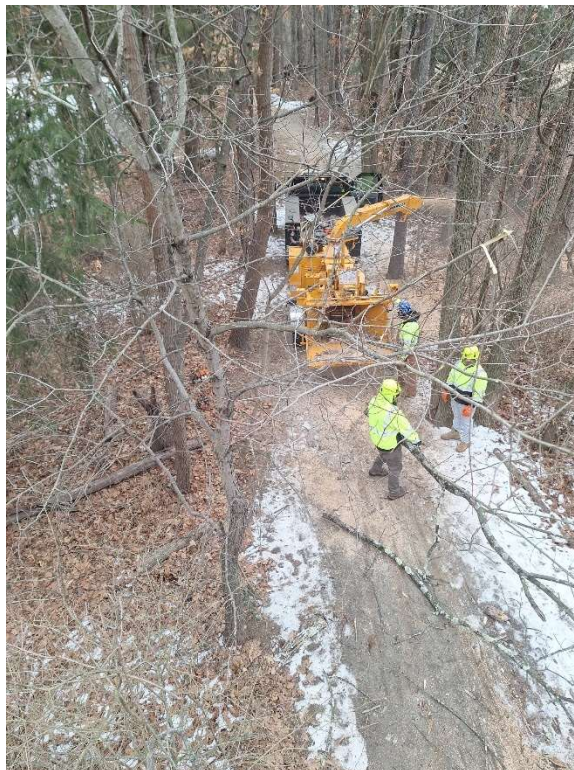
Tree removal work on Dager Rd. Trail

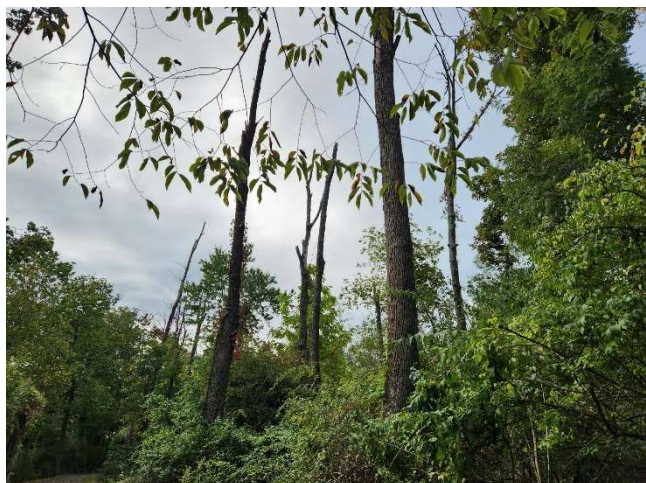
Dead Ash Trees

- Recommendations:
  - Removal of hazardous trees along this trail should be top priority, due to the significant potential for failure of many of these trees. An estimated 50 trees along this trail present significant risk and should be removed as soon as possible. An annual evaluation should be conducted thereafter to determine if additional removals or other tree work would be advisable for this trail segment. Where tree parts are small enough to chip, chips should be spread within the surrounding wooded areas. Stumps should be left in place to decompose. Some larger tree parts should be left in place to decompose, so long as large piles of logs are not created.

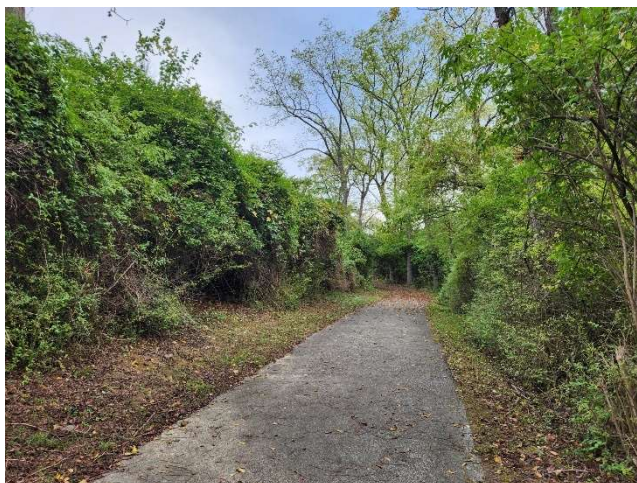
Invasive shrubs along trail

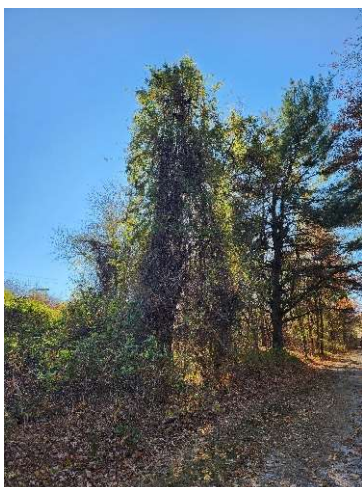
Tree with strangling vines

- Due to the large amount of invasive shrubs on the site, wholesale removal would not be practical, feasible, or fiscally advisable. However, focus could be placed on the removal of vines that are strangling trees on the site. Vine removal should be addressed in areas where it is an issue by cutting the vines at approximately 1' above ground level and returning several times during the next few growing seasons to re-cut new growth until the vines have used up their reserve energy and have died.

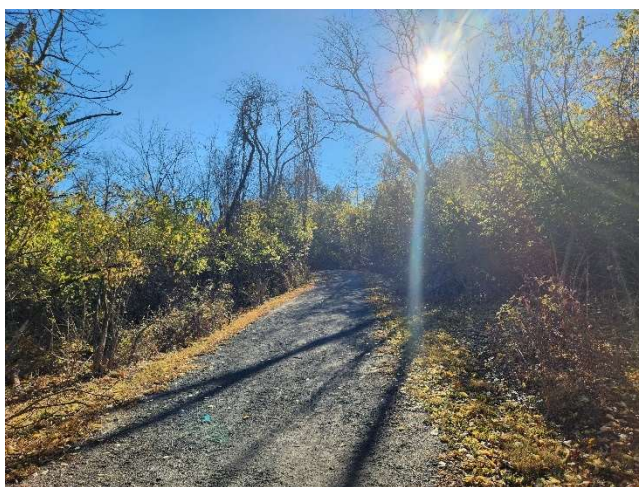
Honeysuckle growth along trail

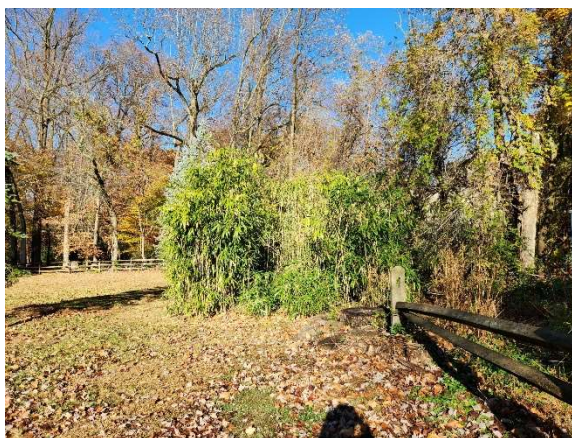
Bamboo encroaching easement

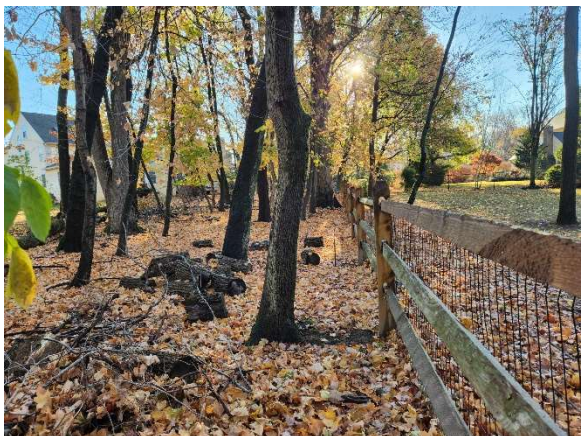
Fencing encroachment within easement

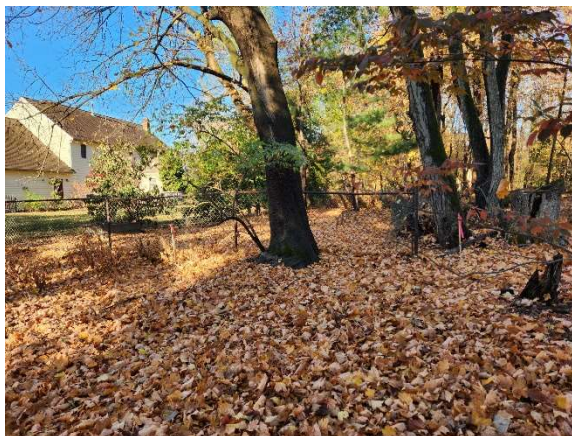
Fencing encroachment within easement

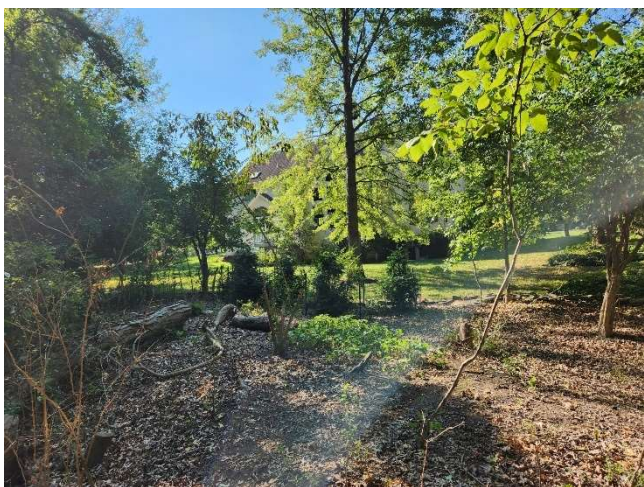
Encroachment by neighbors

- A clear delineation of the property boundaries between the Township property and neighbors is recommended. Following a survey of the property boundaries, delineation of the property corners could be made by the planting of small shade trees or large shrubs at each of the property corners.

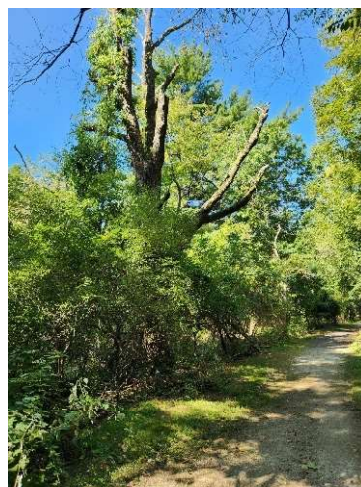
Large dead tree, vine growth, and invasives

- Vine removal should be addressed in areas where it is an issue by cutting the vines at approximately 1' above ground level and returning several times during the next few growing seasons to re-cut new growth until the vines have used up their reserve energy and have died.

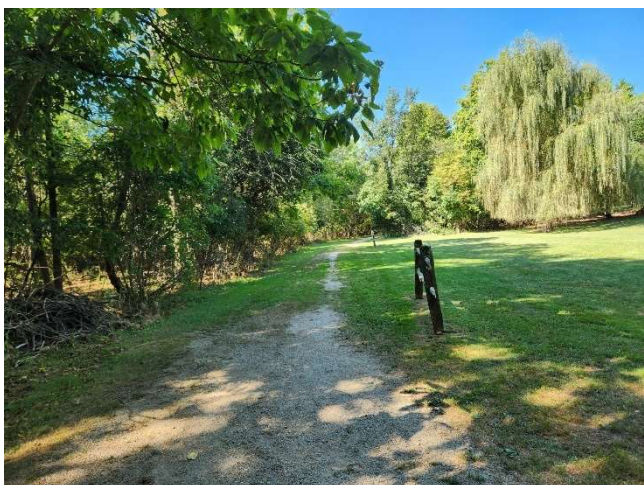
Neighbor maintaining lawn on Township property

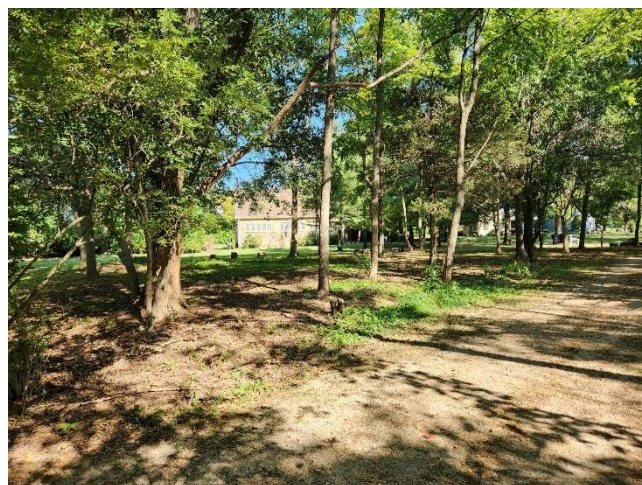
Township property cleared by neighbor

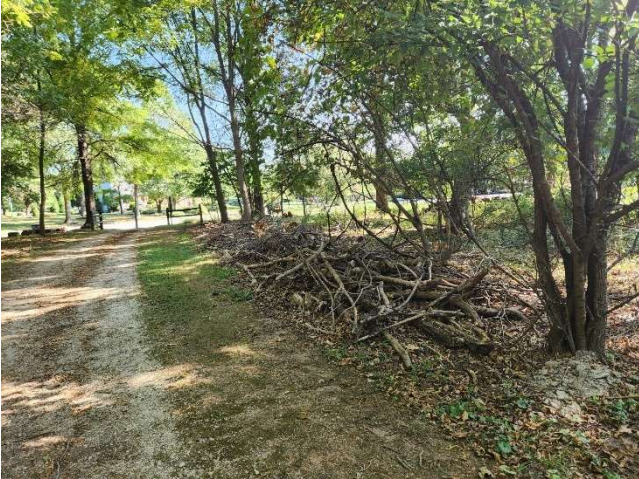
Yard waste deposited by neighbors

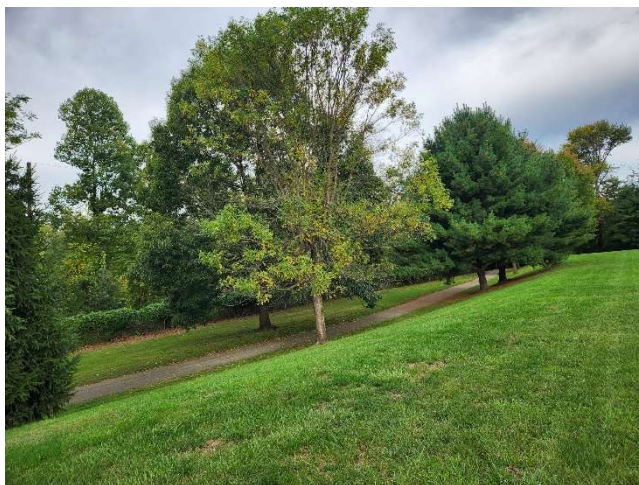
Dying Ash tree

- Plant ornamental shrubs to the rear of the amphitheater stage
- Remove remaining three (3) dead/dying Ash trees
- Plant 2-3 additional shade trees behind amphitheater lawn seating area

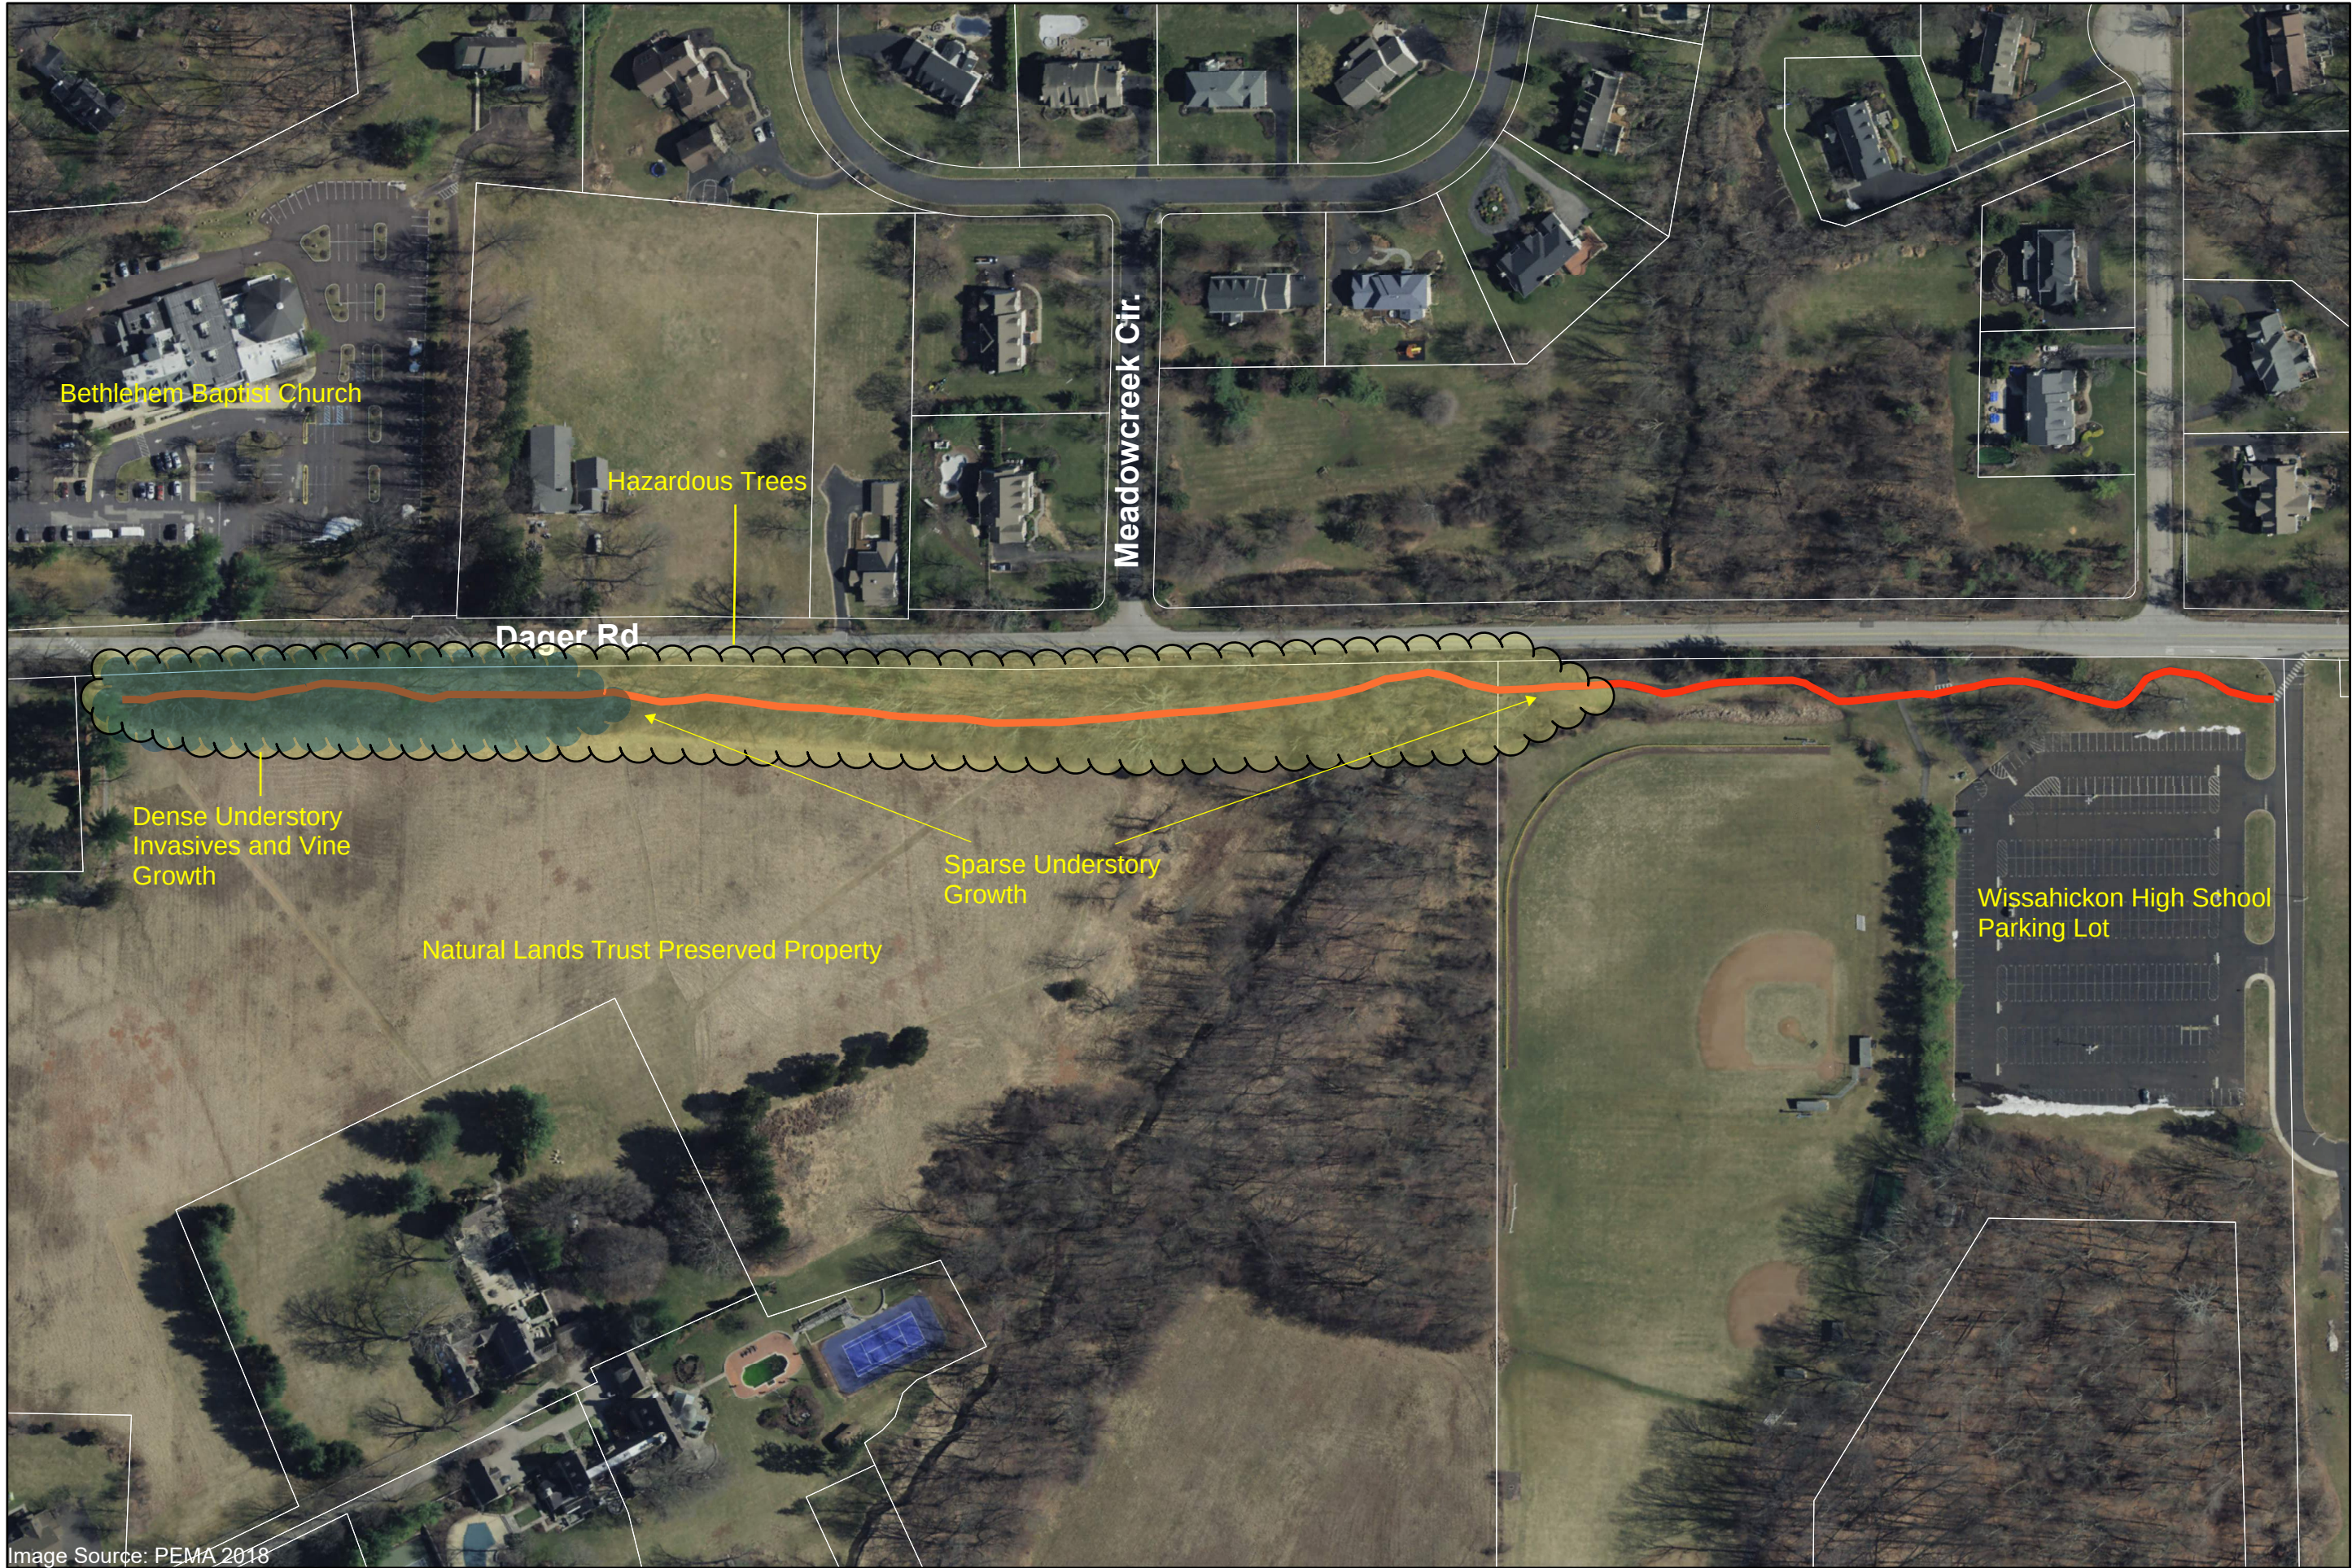
Dager Road Trail

Hazardous Trees

Dense Understory  
Invasives and Vine  
Growth
