FOREST EVALUATION AND  
STRATEGIC MANAGEMENT PLAN  
FOR FIRST PRIORITY AREAS  
LOWER GWYNEDD TOWNSHIP  
AUGUST 26, 2025

Prepared for:  
Lower Gwynedd Township  
1130 N. Bethlehem Pike  
Spring House, PA 19477

Prepared By:  
Valerie Liggett, ASLA, R.L.A.  
ISA Certified Arborist #PD-2334A  
ISA Tree Risk Assessment Qualified

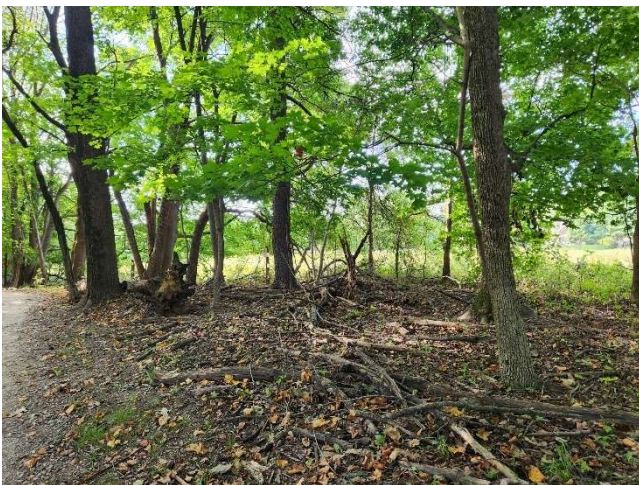
Open understory areas

- Recommendations:
  - An estimated 60-70 hazardous trees have been removed from along the trail. An annual evaluation should be conducted thereafter to determine if additional removals or other tree work would be advisable for this trail segment. Regarding any additional tree removal, where tree parts are small enough to chip, chips should be spread within the surrounding wooded areas. Stumps should be left in place to decompose. Some larger tree parts should be left in place to decompose, so long as large piles of logs are not created.

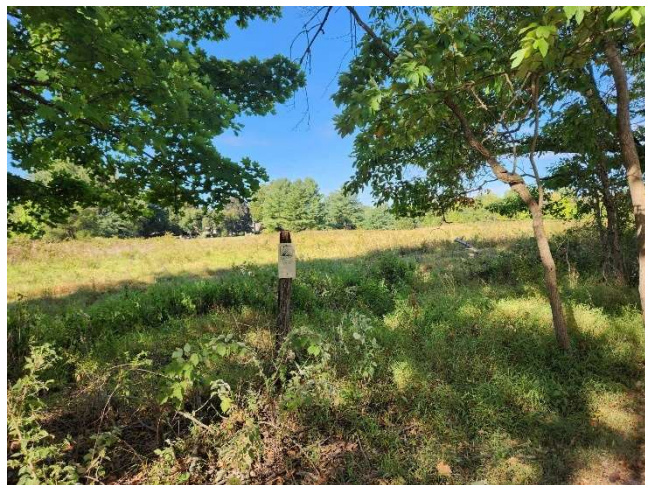
Adjacent Natural Lands Trust preserved property

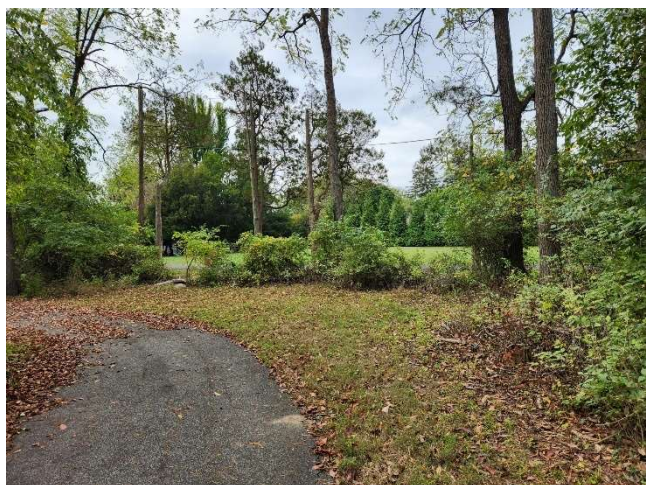
Potential planting area

- Recommendations:
  - Removal of hazardous trees along this trail should be top priority, due to the significant potential for failure of many of these trees. An estimated 50 trees along this trail present significant risk and should be removed as soon as possible. An annual evaluation should be conducted thereafter to determine if additional removals or other tree work would be advisable for this trail segment. Where tree parts are small enough to chip, chips should be spread within the surrounding wooded areas. Stumps should be left in place to decompose. Some larger tree parts should be left in place to decompose, so long as large piles of logs are not created.

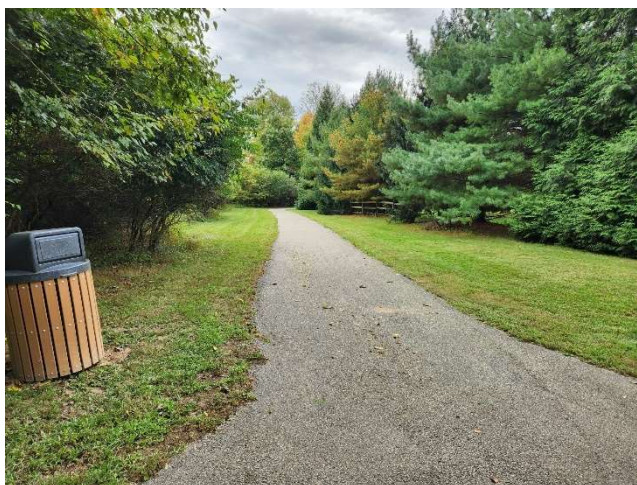
Potential planting area

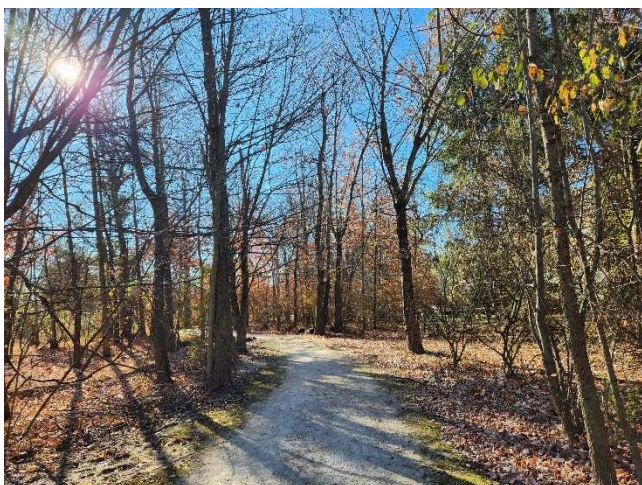
Potential understory planting location

- Recommendations:
  - Removal of hazardous trees along these trail segments should be top priority, due to the significant potential for failure of many of these trees. An estimated 25-35 trees along this trail present significant risk and should be removed as soon as possible. An annual evaluation should be conducted thereafter to determine if additional removals or other tree work would be advisable for this trail segment. Where tree parts are small enough to chip, chips should be spread within the surrounding wooded areas. Stumps should be left in place to decompose. Some larger tree parts should be left in place to decompose, so long as large piles of logs are not created.

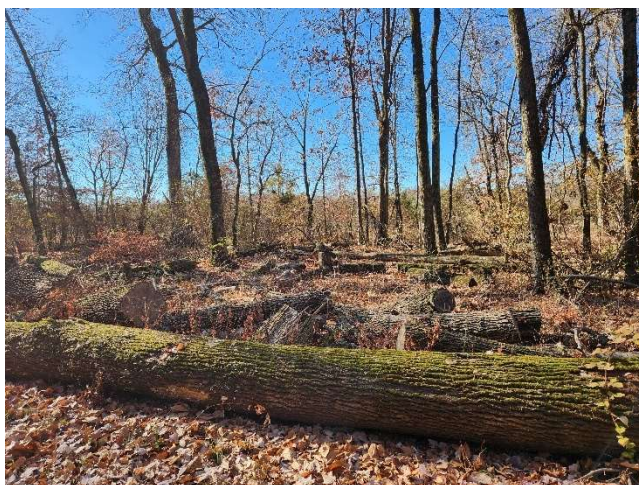
Potential understory planting location

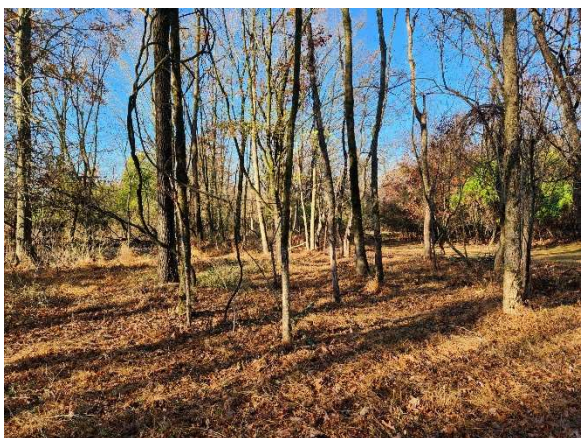
Wooded area adjacent Penllyn Creek

- Recommendations:
  - Removal of hazardous trees along this trail segment should be top priority, due to the significant potential for failure. Approximately 10 trees within the easement should be removed. These trees are located near property lines with adjoining neighbors. Coordination will be necessary with adjoining homeowners to remove hazardous trees on Township properties, along with encroaching fencing and vegetation. Where tree parts are small enough to chip, chips should be spread within the surrounding wooded areas. Stumps should be left in place to decompose. Due to the limited width of the easement, trunks that are not able to be chipped may need to be hauled off-site.

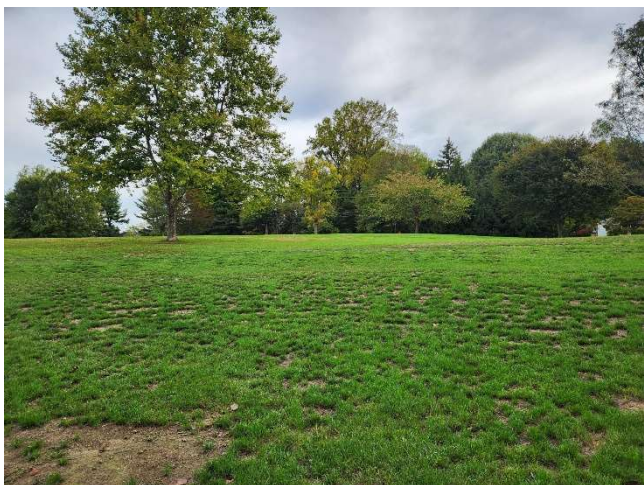
Potential tree planting area to rear of amphitheater

Areas for potential planting are limited due to the nature of the amphitheater, which needs clear sight lines from viewing areas. The attached plan notes potential locations for the planting of 2-3 additional shade trees to the rear of the lawn seating area, as well as a location for shrubs which could serve as a 'backdrop' to the amphitheater stage.
